_____GEOMORPHIC STABILITY OF
SANDBAR 43.1L ON THE COLORADO RIVER IN
THE GRAND CANYON IN RESPONSE TO
GROUND WATER SEEPAGE DURING
FLUCTUATING FLOW RELEASES FROM
GLEN CANYON DAM

Technical Report NPS/NRWRD/NRTR-92/10

July 1993

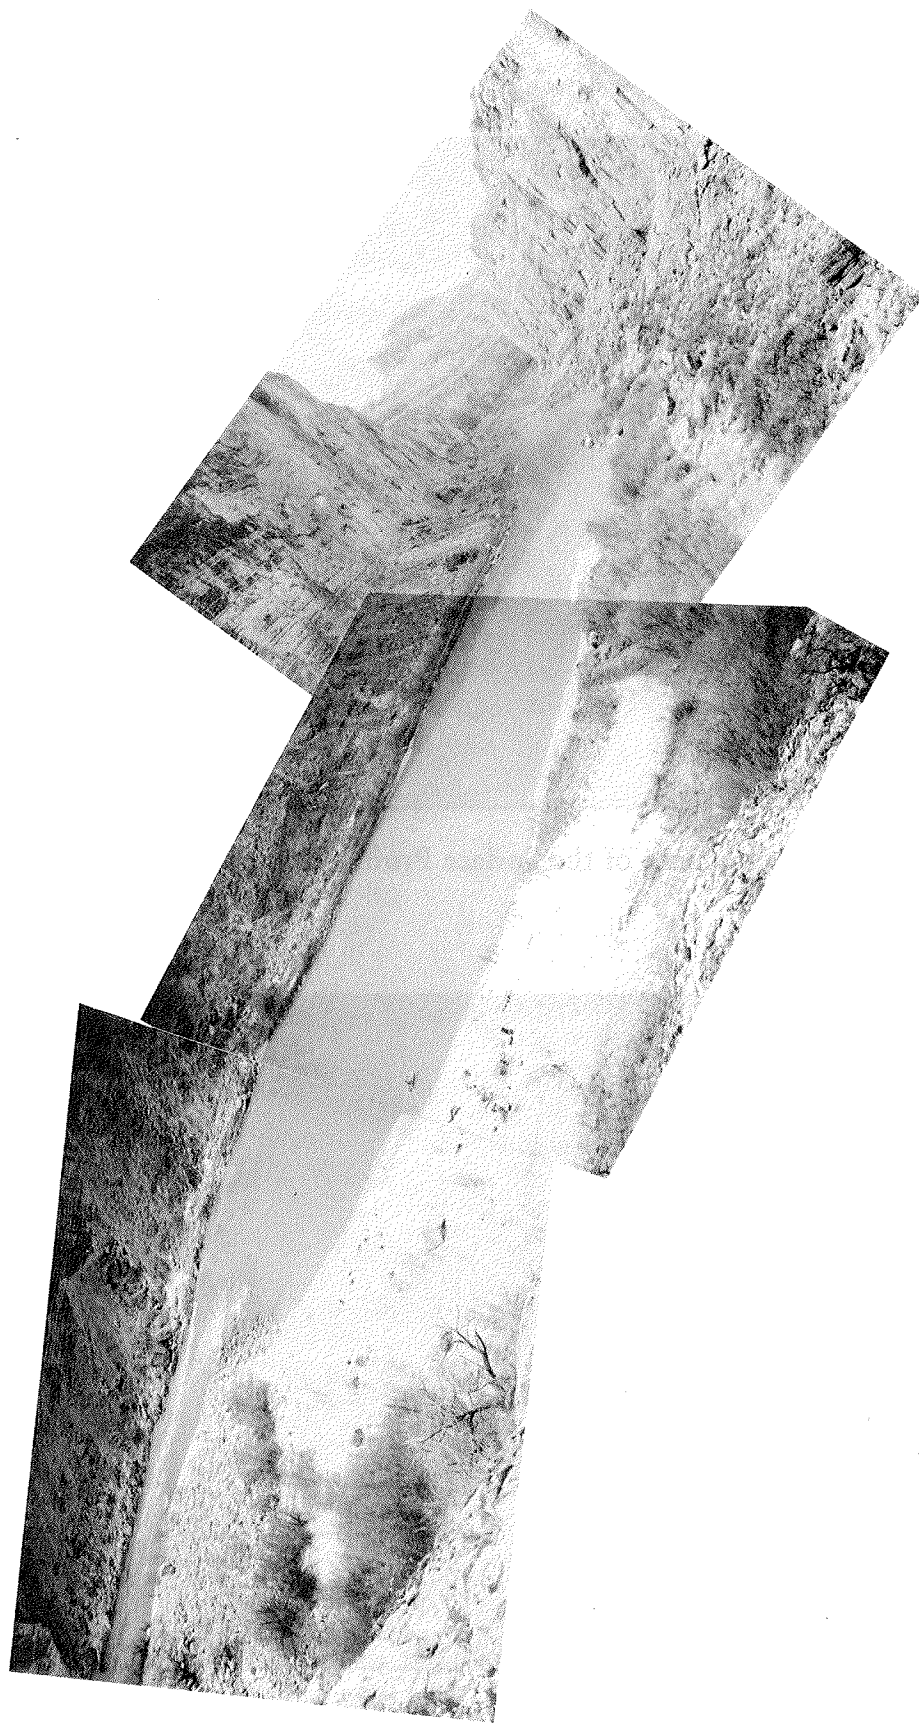
PHOTO 1. Panoramic view of Sandbar 43.1L, looking south. River flow is from right to left.

The main current of the Colorado River as determined by surface flow directions is separated from the sandbar face by two eddies. Each eddy is adjacent to the sandbar and is elongated, parallel to the shore. One eddy is offshore for approximately the downstream half of the sandbar, and the other eddy is correspondingly present for the upstream half. The eddies were present at all observed river stages, and both have counterclockwise circulation directions. Upstream flow currents adjacent to the shore ranged from near zero to about 0.6 meters per second (m/s). Eddy circulation extends to about 10 m from shore. At the contact point between the two eddy cells, the sandbar is more gently sloped and projects into the river about 2 - 3 m. In August 1991, the eddy shapes were observed at low and high river stages. There was no longitudinal shift from low to high flow, only lateral compression or expansion of the eddies. Because they move little, the point in the center of the bar is coincident with the stagnation point between the two eddies. (B. Cluer 1991, personal communication). A panoramic view of the study site is shown in Photo 1.

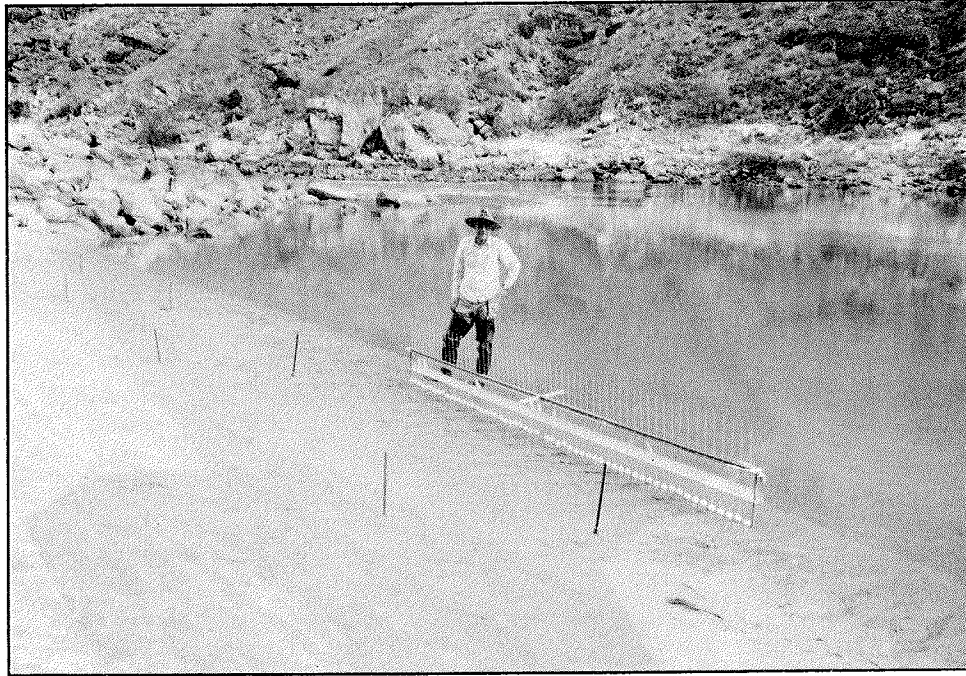
PHOTO 2. Employment of the Surface Profile Gage in April 1991.

Transects were established by driving lengths of rebar into the sandbar at a predetermined distance apart, 4.5 m (14.8 feet [ft]). This distance corresponded to that required to support the Surface Profile Gage. The gage was designed and constructed to allow accurate measurement of erosion or deposition of the site without trampling or other anthropogenic disturbance of the transect (Photos 2 and 3). A description of the Surface Profile Gage is included as Appendix 2. The rebar remained in place throughout the study period, serving to both support the Surface Profile Gage and to insure that repeated measurements were taken exactly along the same line. The Surface Profile Gage was positioned on the rebar, and 58 vertical

measuring rods with ping-pong balls attached to the lower end, were allowed to drop to the ground surface. The ping-pong balls prevented the rods from penetrating the sand surface. The vertical rods were clamped in position and the gage was removed to measure and record the extended distance of each rod. The mean rod length for each transect was computed to indicate mean values of erosion or deposition over the entire length of the transect. Mean elevations were computed using values for balls numbering 6 - 54, from the center part of each transect. Balls numbering 1 - 5 and 55 - 59, located at each end of the transect, were not used in computing means in order to omit data which might have been subject to footprint disturbance near the edges of the transect (i.e., to insure that only data from undisturbed areas were used in computing mean elevations). Repeated measurements allowed determination of ground surface elevation changes. Measurements were converted to elevations relative to an arbitrary local datum.

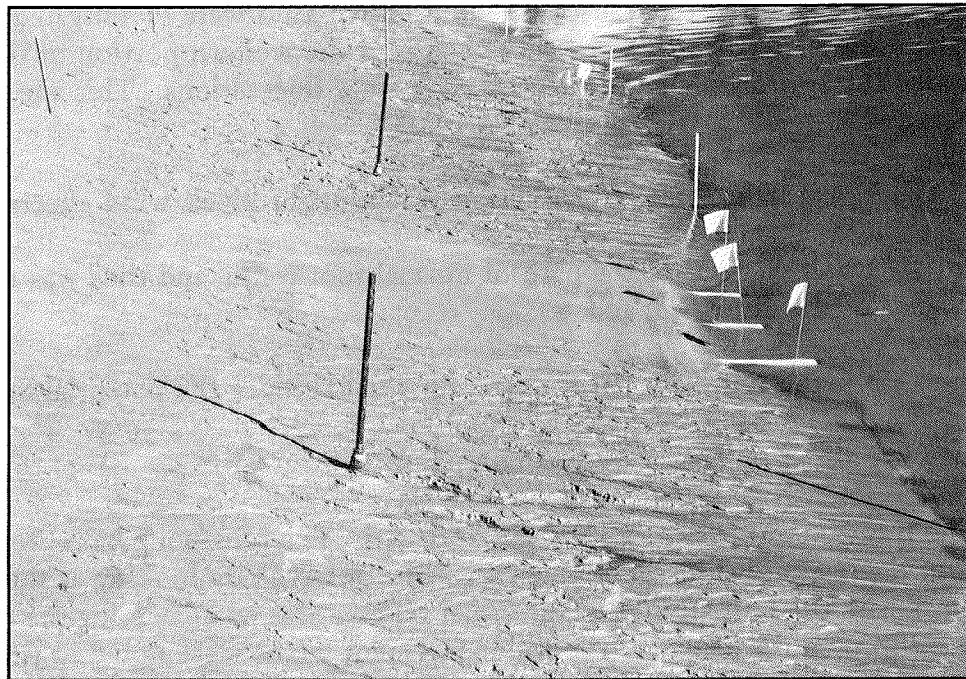
PHOTO 5. Plot 3 with perforated lateral drains as seen at the center of the photo. Note relatively dry sand without rivulets overlying the drains. Plot 2 with blank pipe is seen in the upper center of the photo. Wet sand and rivulets are seen overlying these pipes.

Photos of lateral drains taken April 7, 1991, approximately 24 hours after installation.
